Appendix D: SAFETY ASSESSMENT REPORT

EXEMPLARY DETAILED SAFETY ASSESSMENT REPORT

Re: Grade Crossing Safety Assessment:
Main St., Pleasantville
Rail Company mile 98.76, Pleasantville Subdivision

**TABLE 1: Grade Crossing Safety Assessment: Main Street, Pleasantville, NB
Canadian National, mile 98.76, Pleasantville Subdivision**

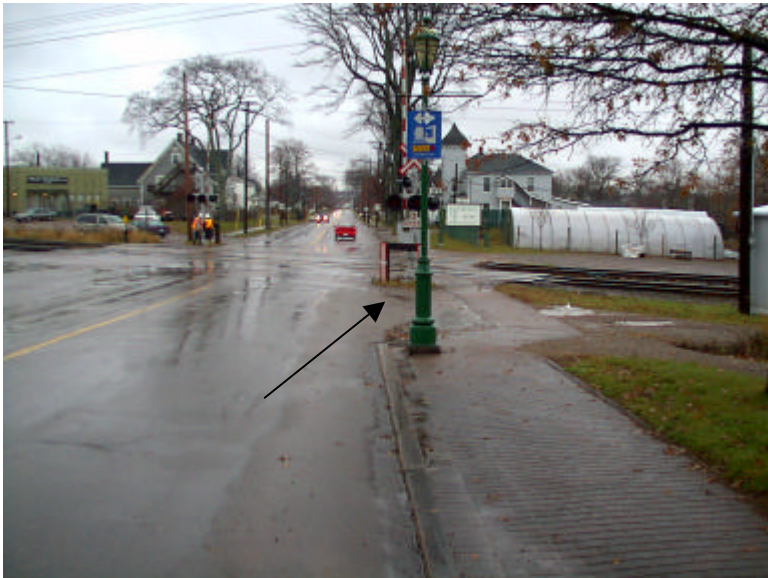
4.0 Warning System			
a. The base structure for both the north and south gates are located too close to the travel lanes (see Figures 3,4 and 7). This is likely a result of street widening that has occurred at some point.	Reposition gate structures or provide additional crash protection.

Photo 3: Southbound Main showing alignment of gate hardware

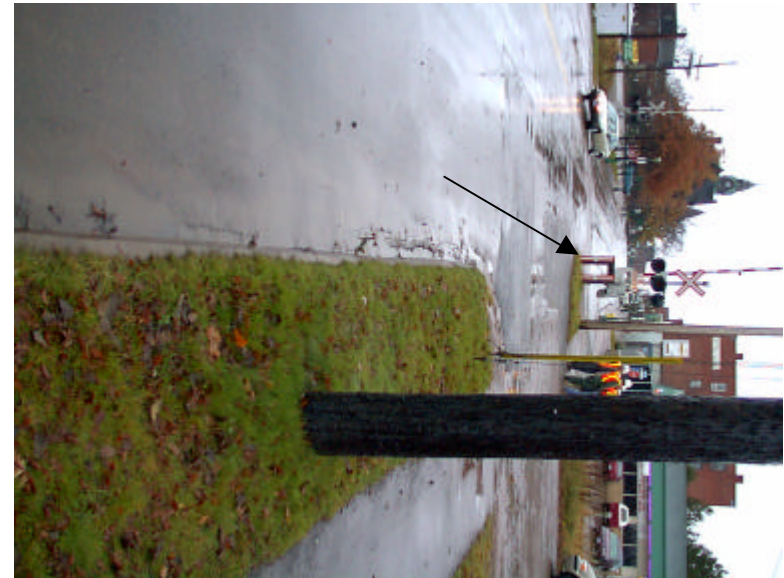
Photo 4: Northbound Main showing intrusion of gate hardware.

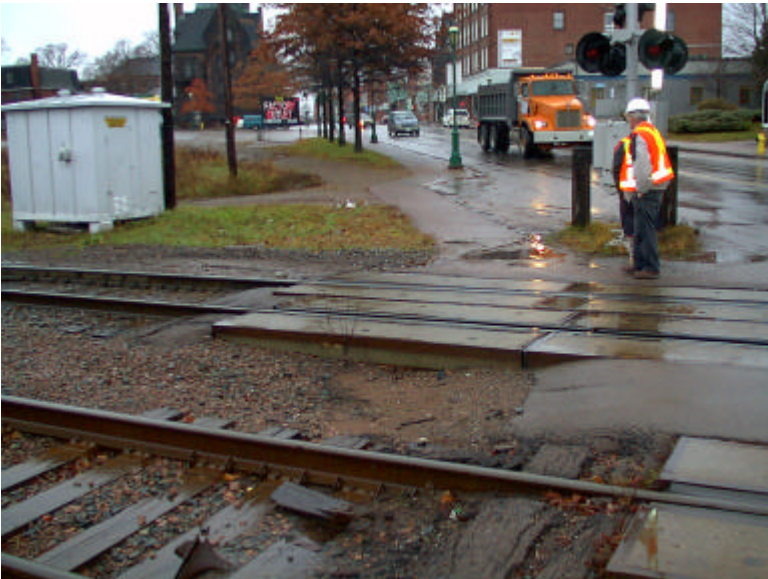
Observations	Suggested Actions	CLIENT RESPONSE	
		Agree yes/no	COMMENTS
3.0 Sidewalks			
a. The crosswalk width provided on the west side of the crossing is not wide enough as illustrated in Photos 5 and 6.	Extend crosswalk as needed.

Photo 5: non-contiguous crosswalk on west side of crossing

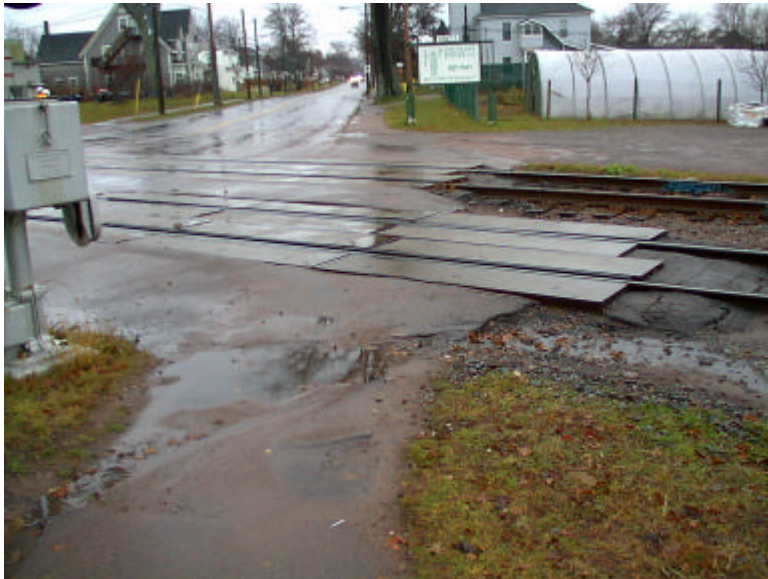
Photo 6: reverse view of Photo 5

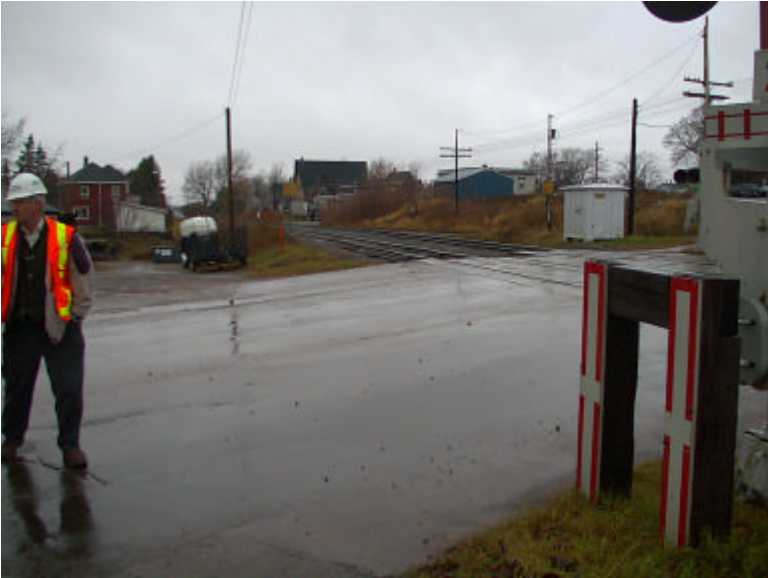
Photo 7: Looking west from northbound Main St.

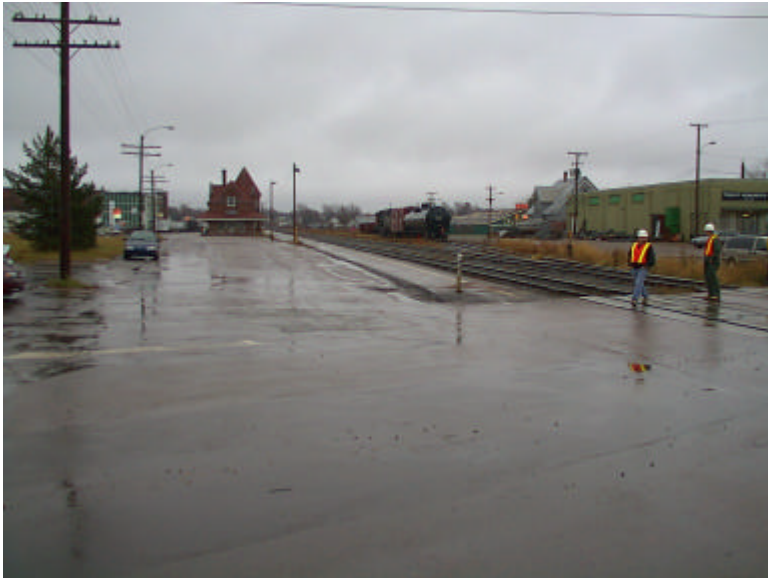
5.0 Miscellaneous			
a. School children were observed crossing the rail line east of the crossing near the rail station. b. Westbound traffic turning left from Maple Street have the potential to by-pass an activated rail crossing gate.	Either restrict access to the rail line or re-institute whistling practices in this area. Consider countermeasures such as prohibiting lefts turns from this street, reconfiguring the street to one-way flow eastbound, or install a supplemental FLB fixture for this approach.

Photo 9: Maple St. adjacent to the crossing in the northeast quadrant

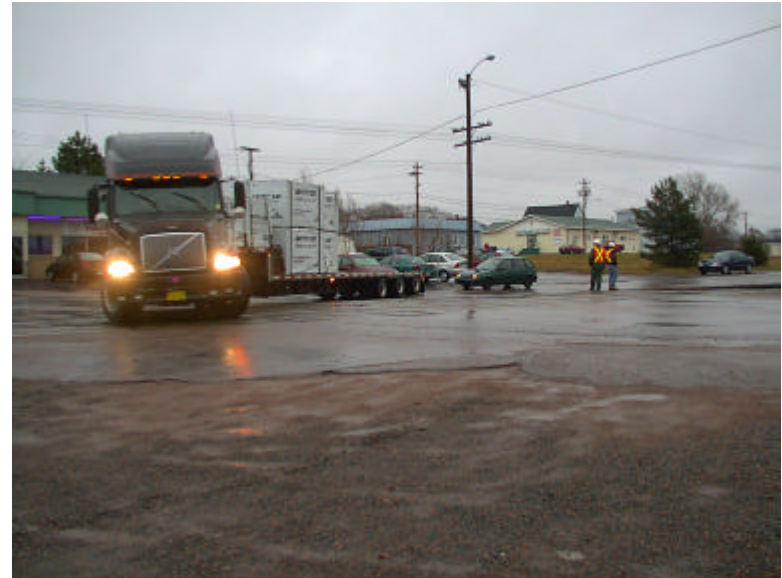
Photo 10: Example of design vehicle
